**REPORT ON  
ROCK SLOPE STABILITY EVALUATION  
KIPP ACADEMY  
LYNN, MASSACHUSETTS**

**Haley & Aldrich, Inc.  
Boston, Massachusetts**

**File No. 36815-003  
8 November 2011**

Subject: Rock Slope Stability Evaluation  
and Treatment Recommendations  
Athletic Field  
KIPP Academy  
Lynn, Massachusetts

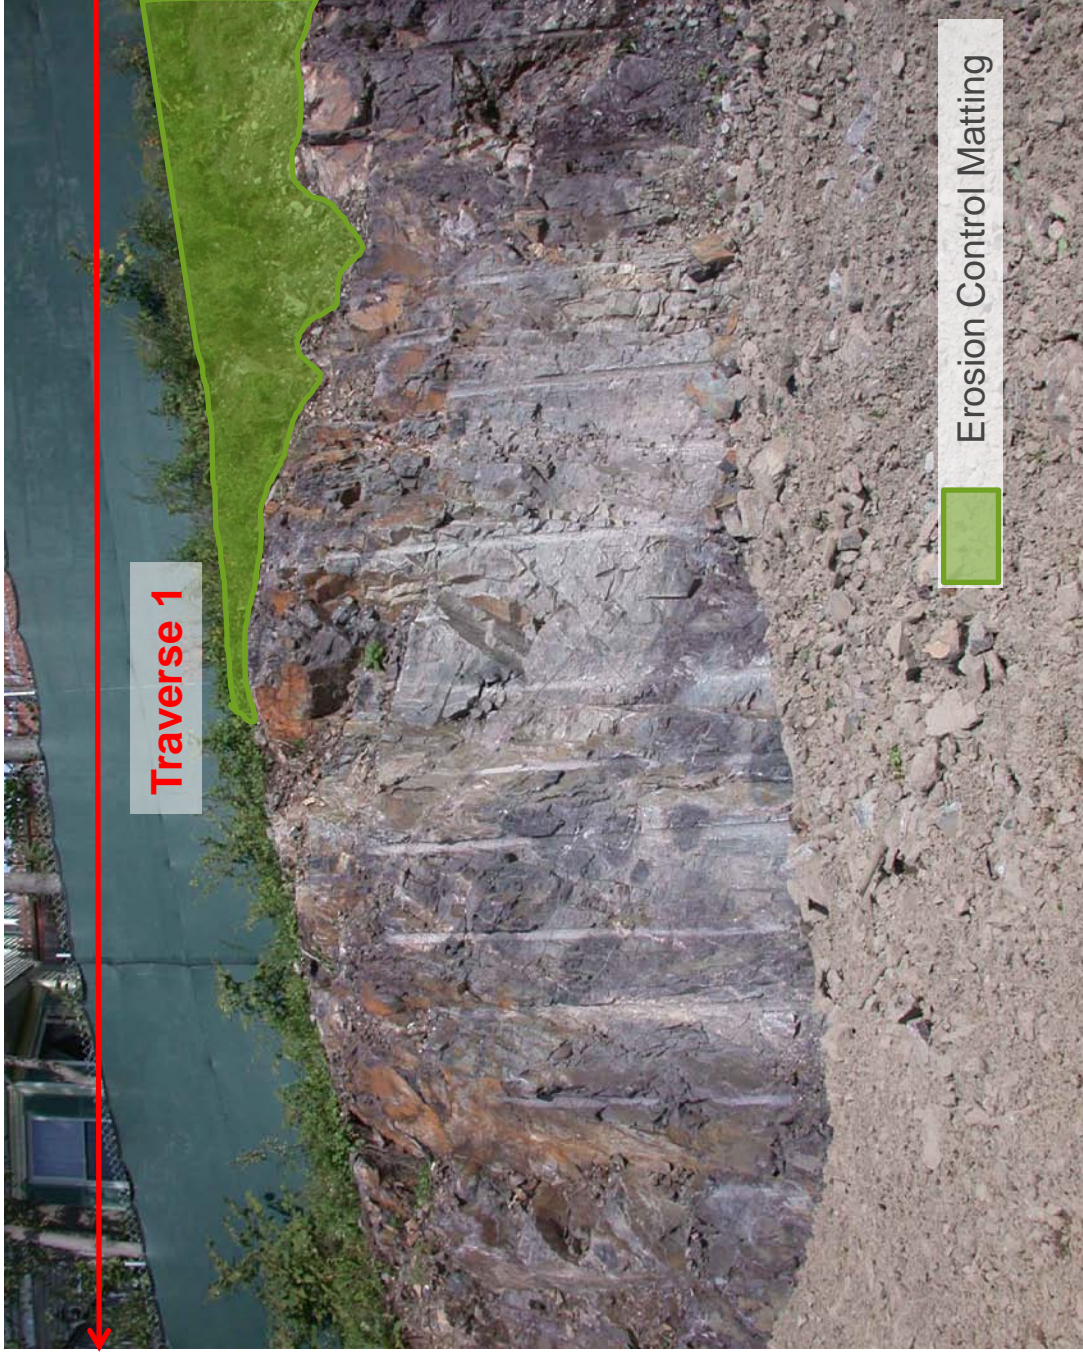
Appendix A Figure 1

Several areas of Traverse 1 slopes were observed to be “wet or moist” where water was seeping from the face or from water flowing over the rock surface from the overlying saturated soil after rain events. These wet areas were noted at the eastern end of the Traverse (near the intersection with Traverse 2) and were located approximately half way up the slope face.

# Traverse 1 – Erosion Control

- Install rock slope drains in two (2) locations in the general location shown in Appendix A (see Figure 2).
- Extend the RECP from the intersection of Traverse 1 with Traverse 2 approximately 25 feet west and away from the rock slope towards the property line (see Appendix A, Figure 1 and Figure 2).

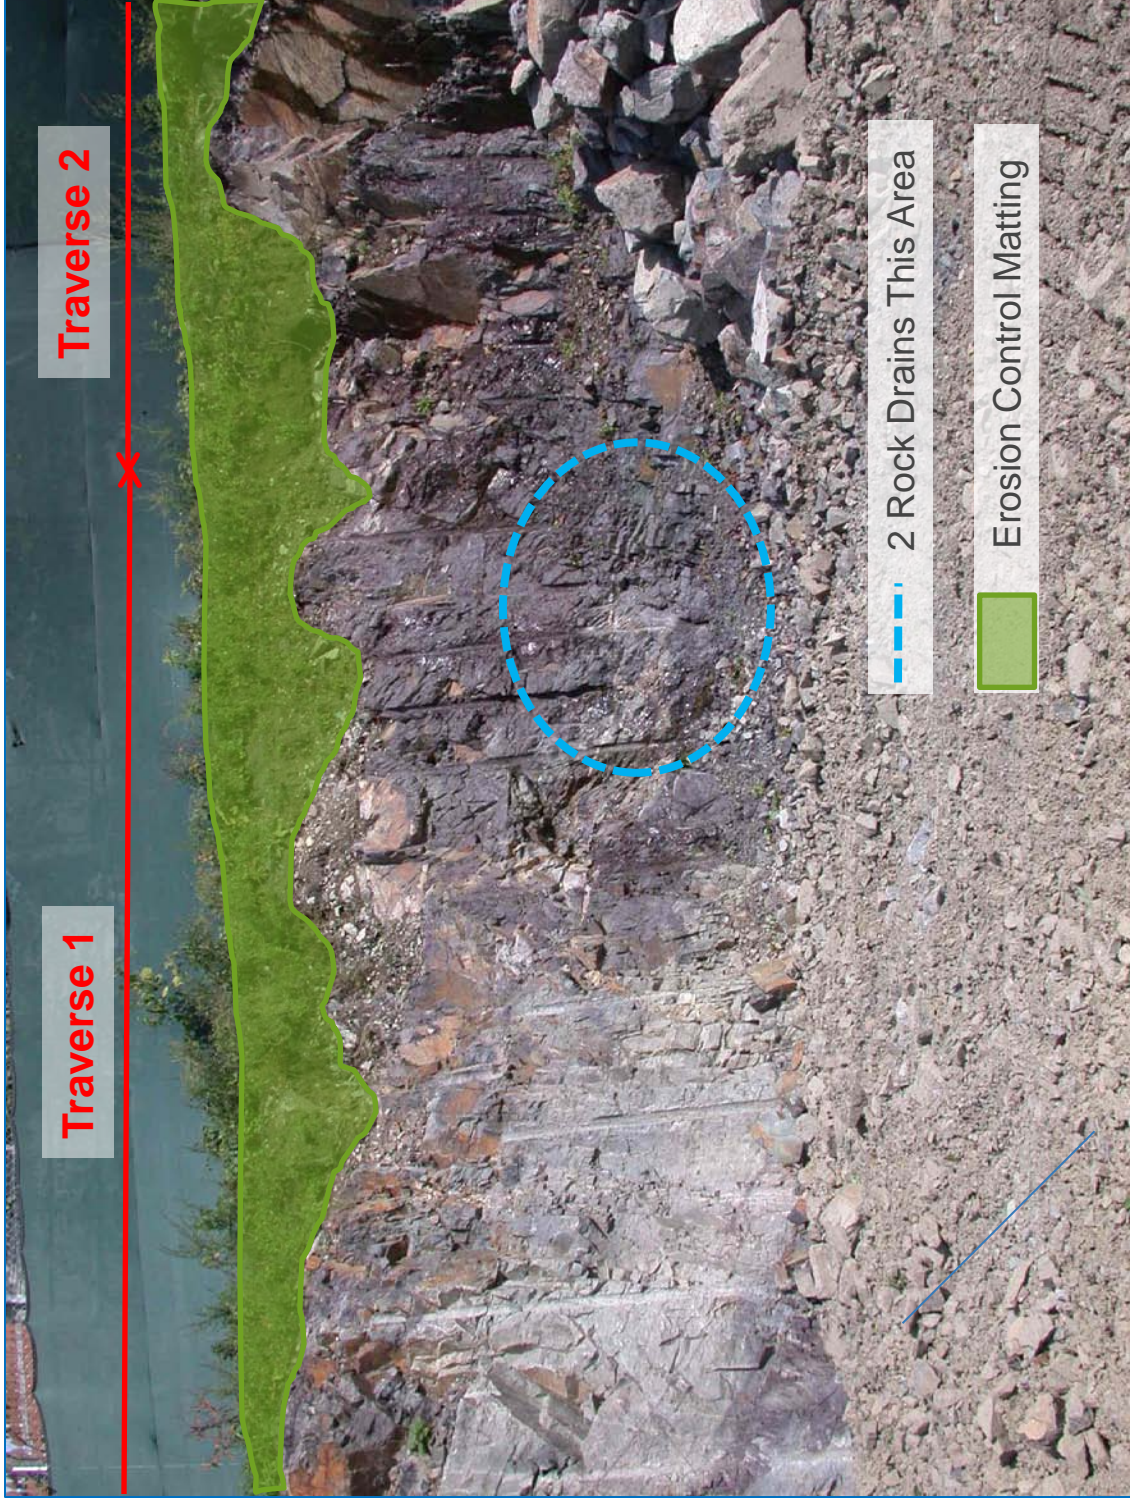
Appendix A Figure 2

# Traverse 1 – Drainage

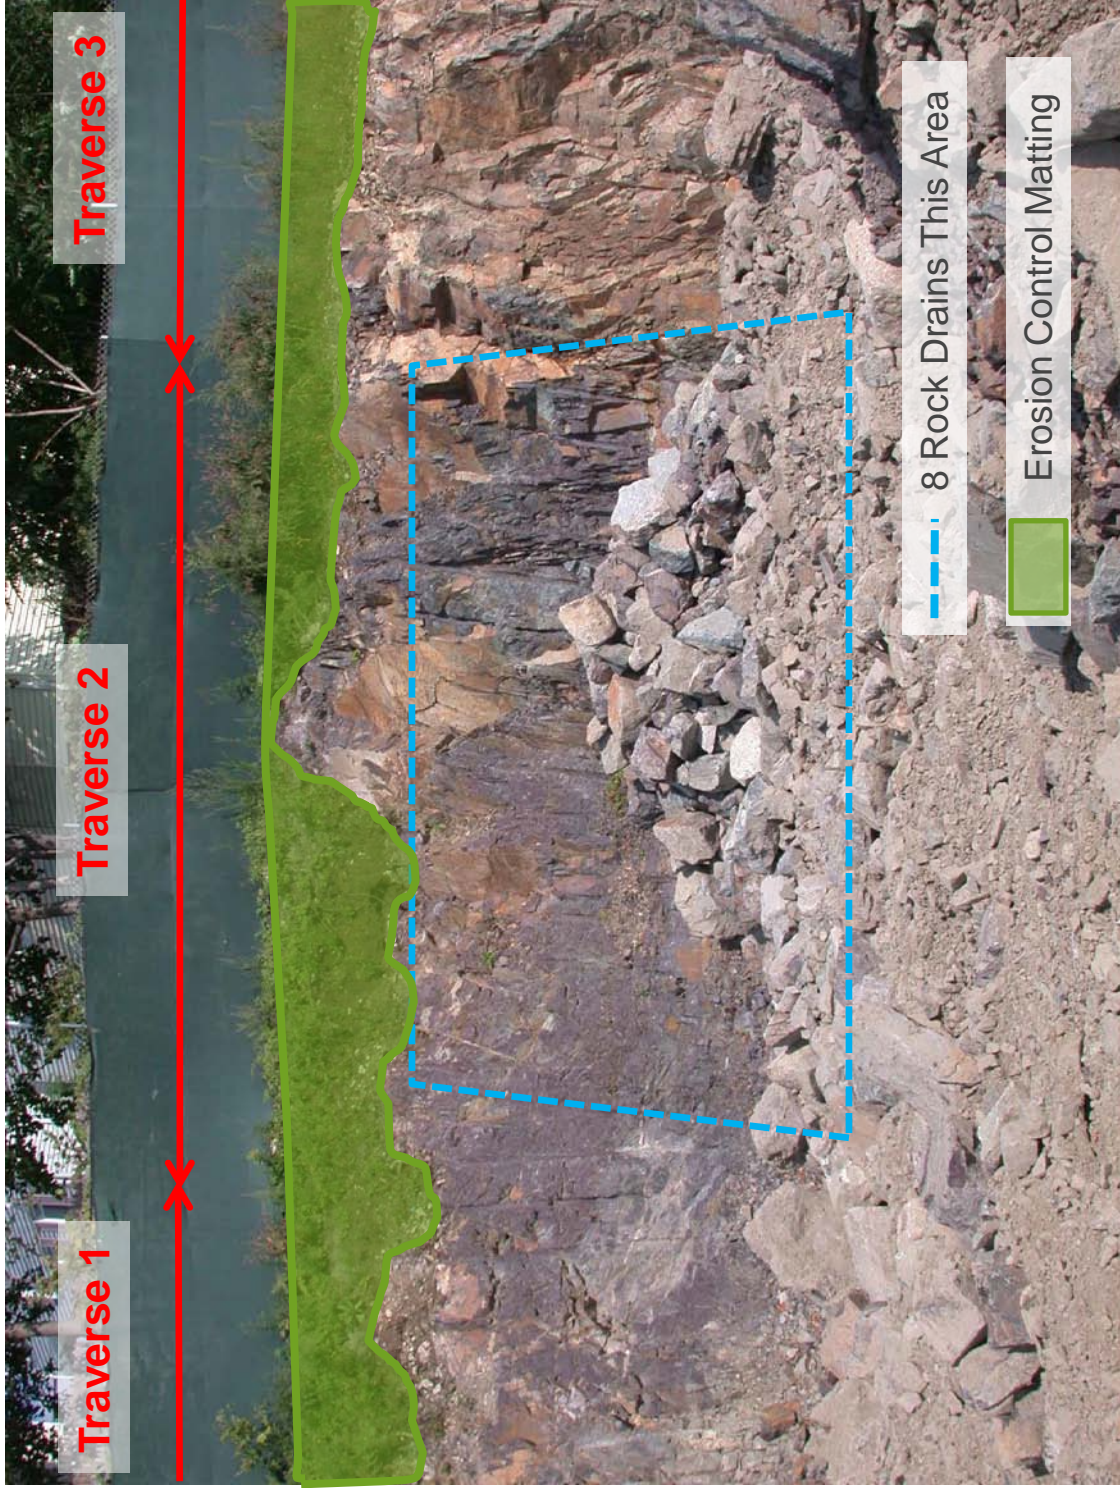
Appendix A Figure 3

Many areas of Traverse 2 were observed as “wet or moist” where water was seeping from the face or from water flowing over the rock surface from the overlying saturated soil after rain events. These wet areas extended up the entire slope face in some areas.

## Traverse 2 – Drainage

- Install rock drains in approximately eight (8) locations as shown in Appendix A (see Figure 3).
- Extend the RECP the entire width of Traverse 2 and away from the rock slope towards the property line (Appendix A, Figure 3).

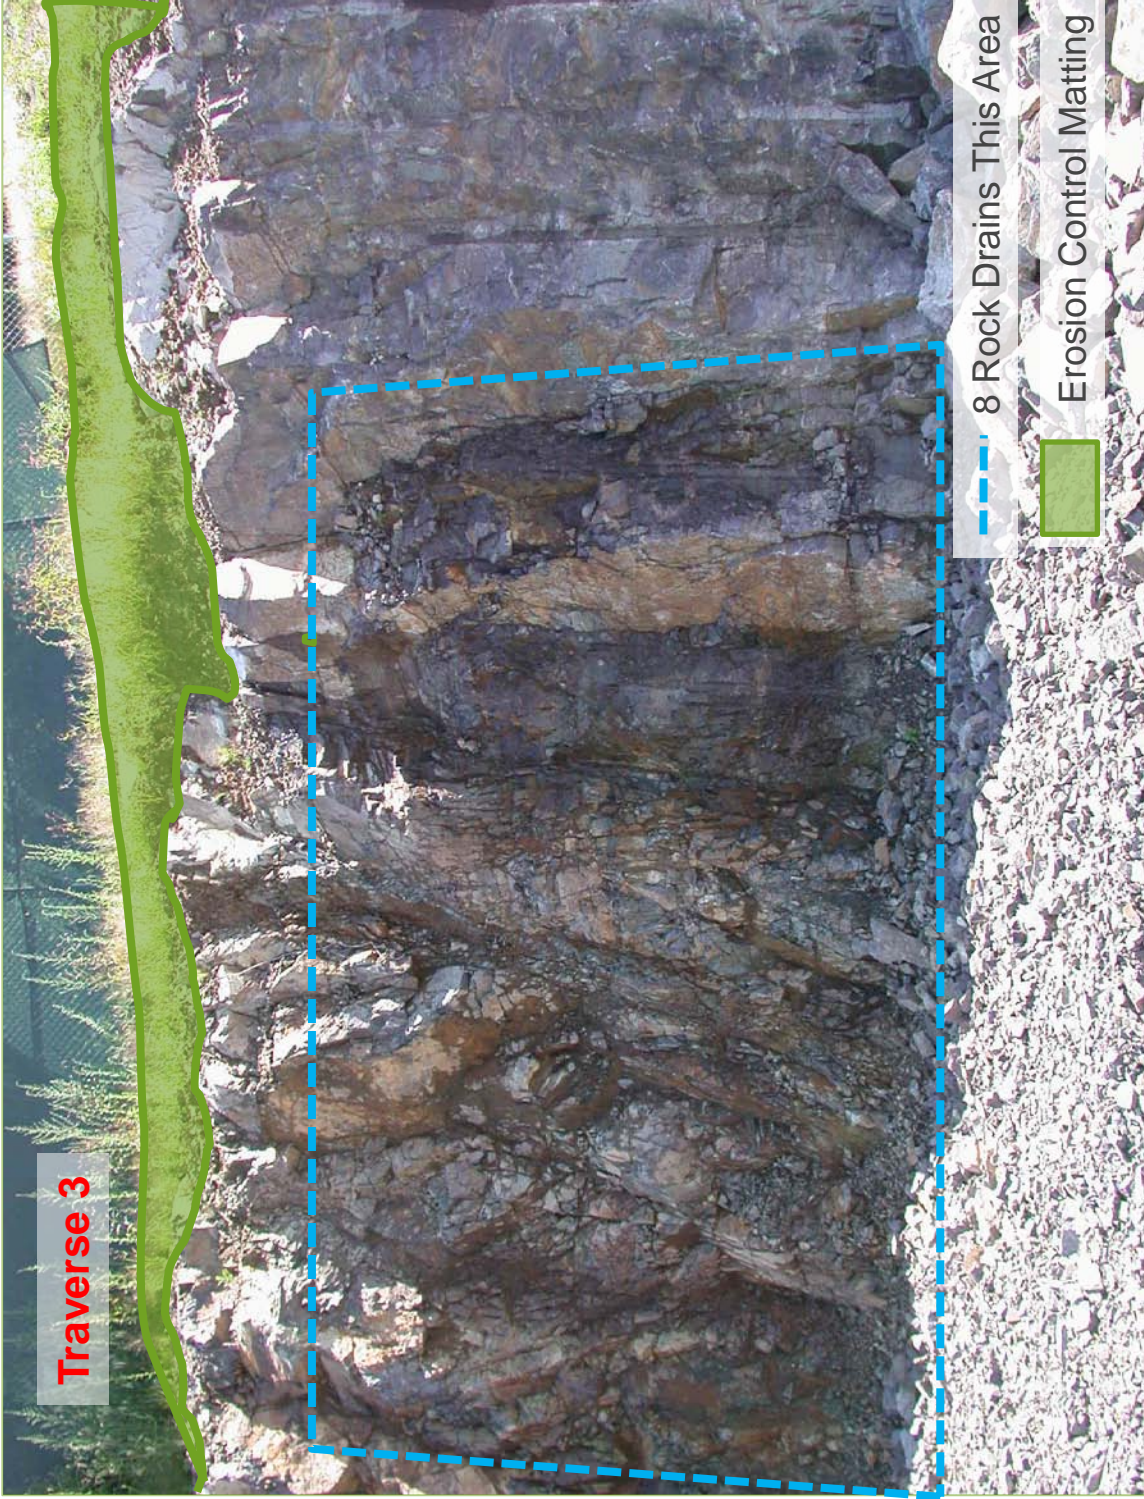
Appendix A Figure 4

Several areas of the slopes were wet or moist where water was seeping from the face or from water flowing over the rock surface from the overlying saturated soil after rain events. These wet areas were noted at the northern end of Traverse 3 (near the intersection with Traverse 2) and several other locations along the rock face. Most were located approximately three-fourths of the way up the slope face.

# Traverse 3 – Drainage

- Install up to twelve (12) passive rock dowels at general locations indicated in Appendix A (see Figures 6 through Figure 9).
- Install rock slope drains in approximately seventeen (17) locations at heights ranging from 2 feet above the final toe-of-slope grade to approximately three-fourths of the way of the slope face (see Appendix A, Figures 4, 5 and 6).
- Extend RECP from Traverse 2 approximately 35 feet down Traverse 3 (see Appendix A, Figure 5 and Figure 6).

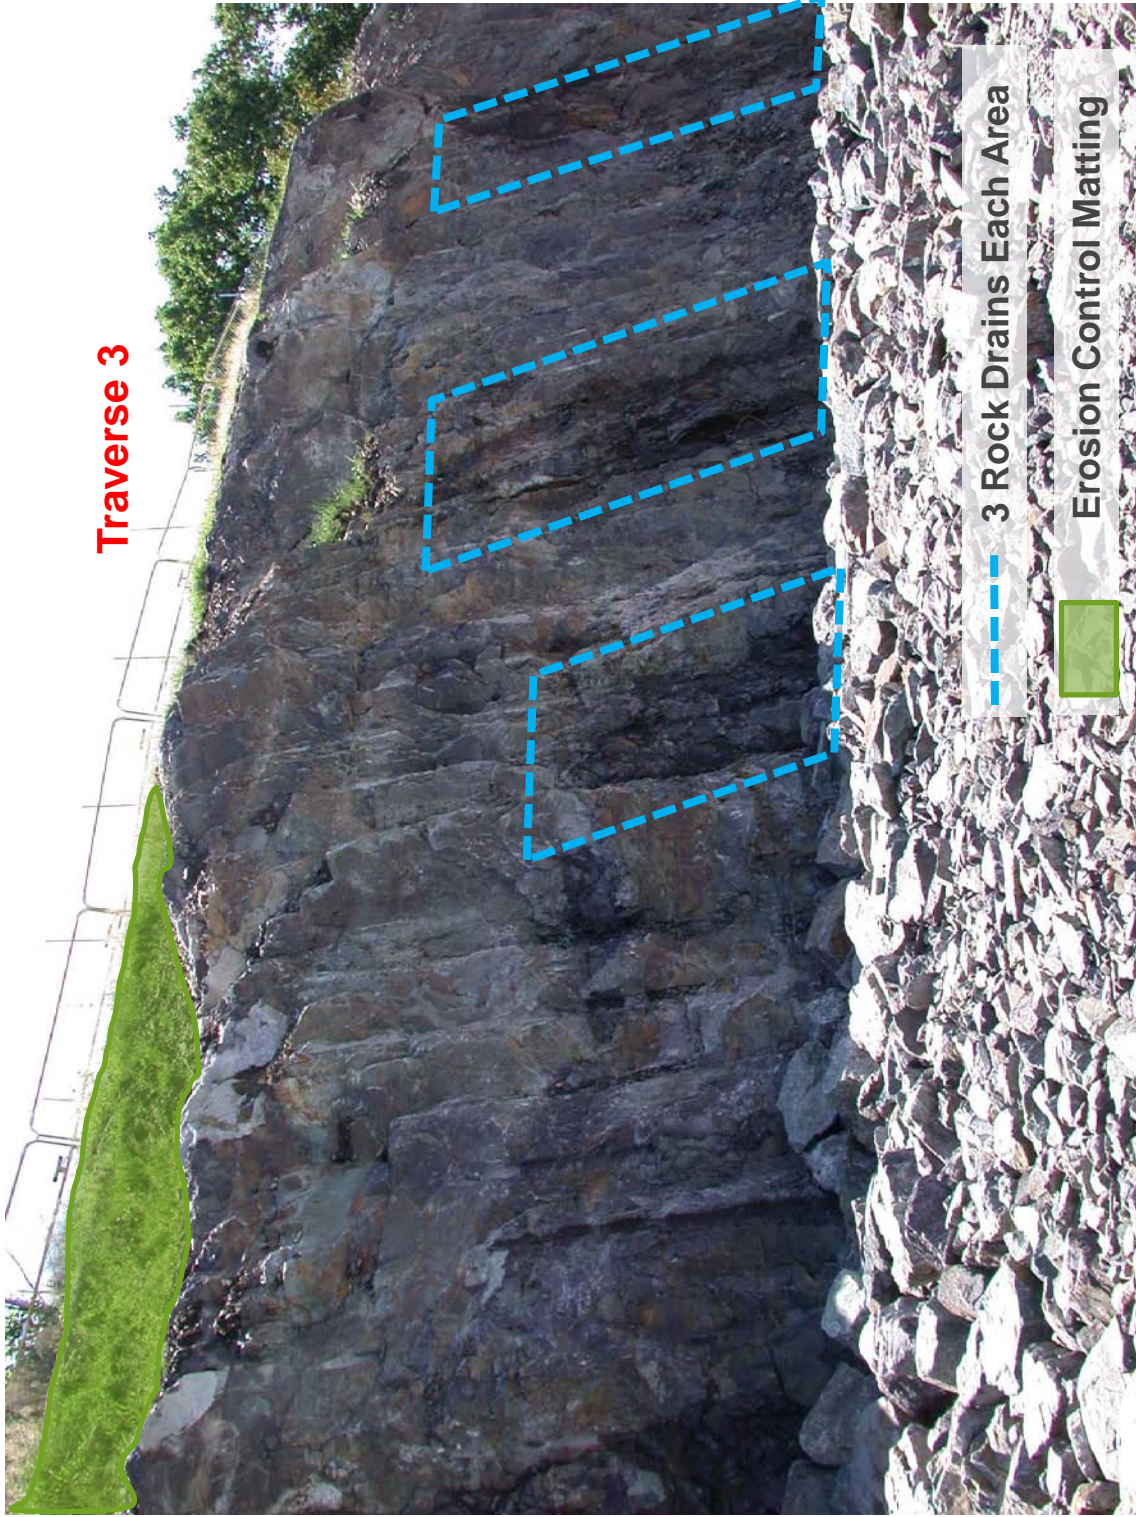
Appendix A Figure 5

# Traverse 3 – Drainage

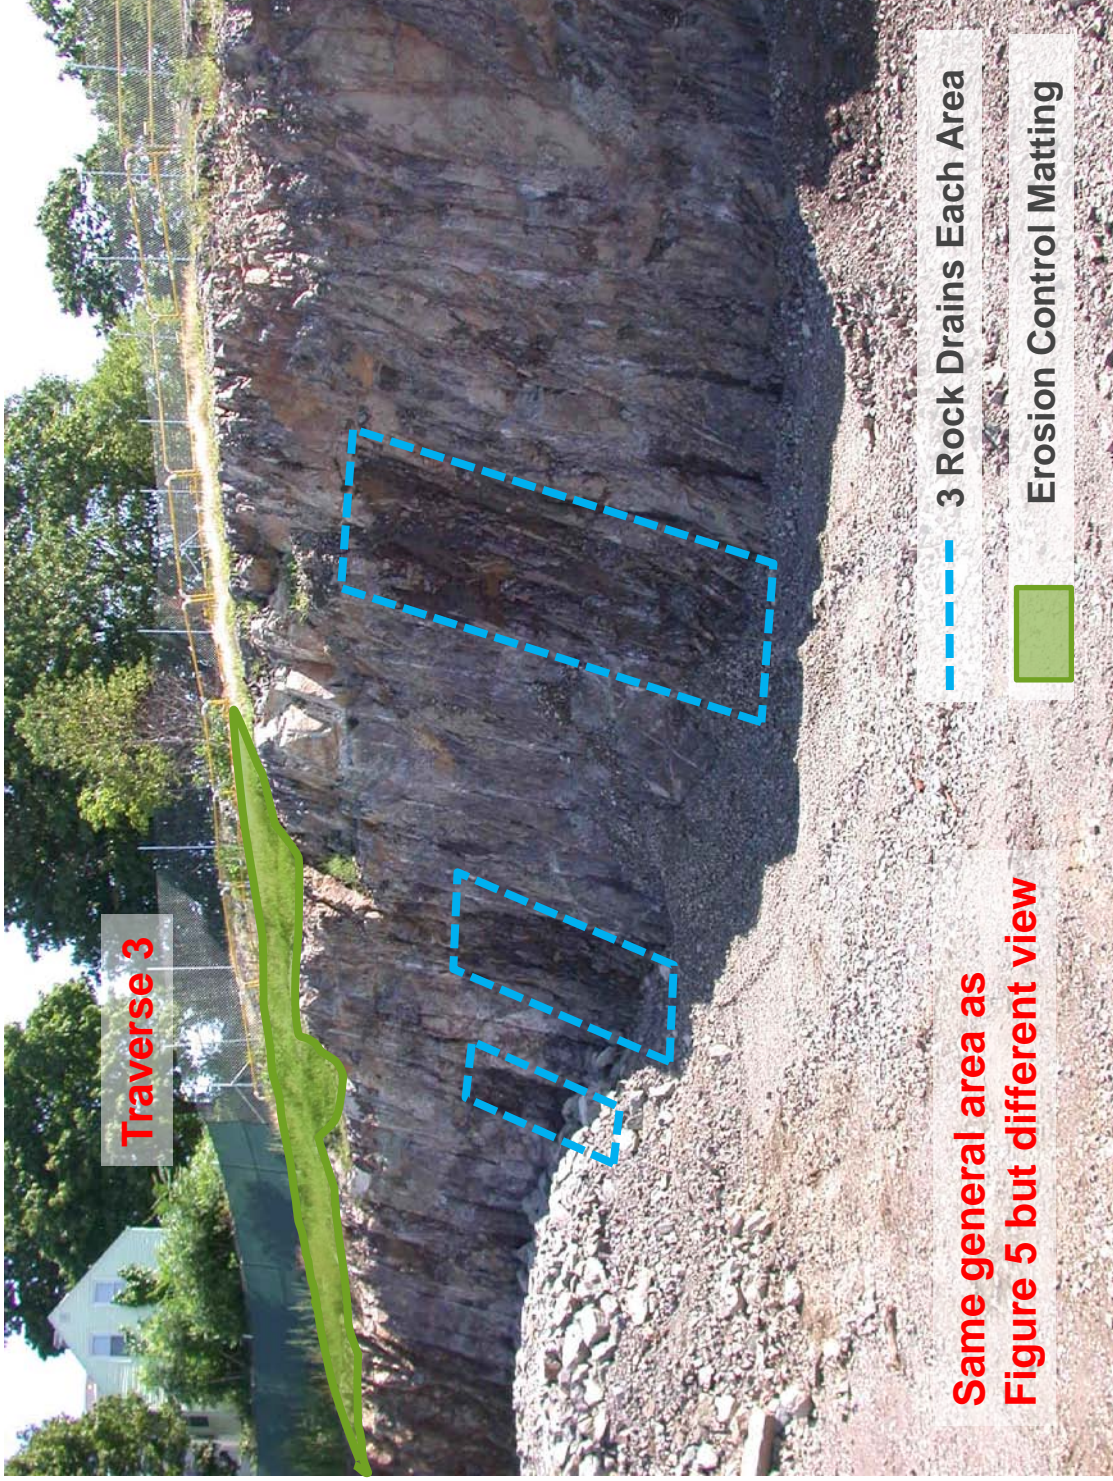
**Same general area as Figure 5 but different view**

## Traverse 3 – Drainage

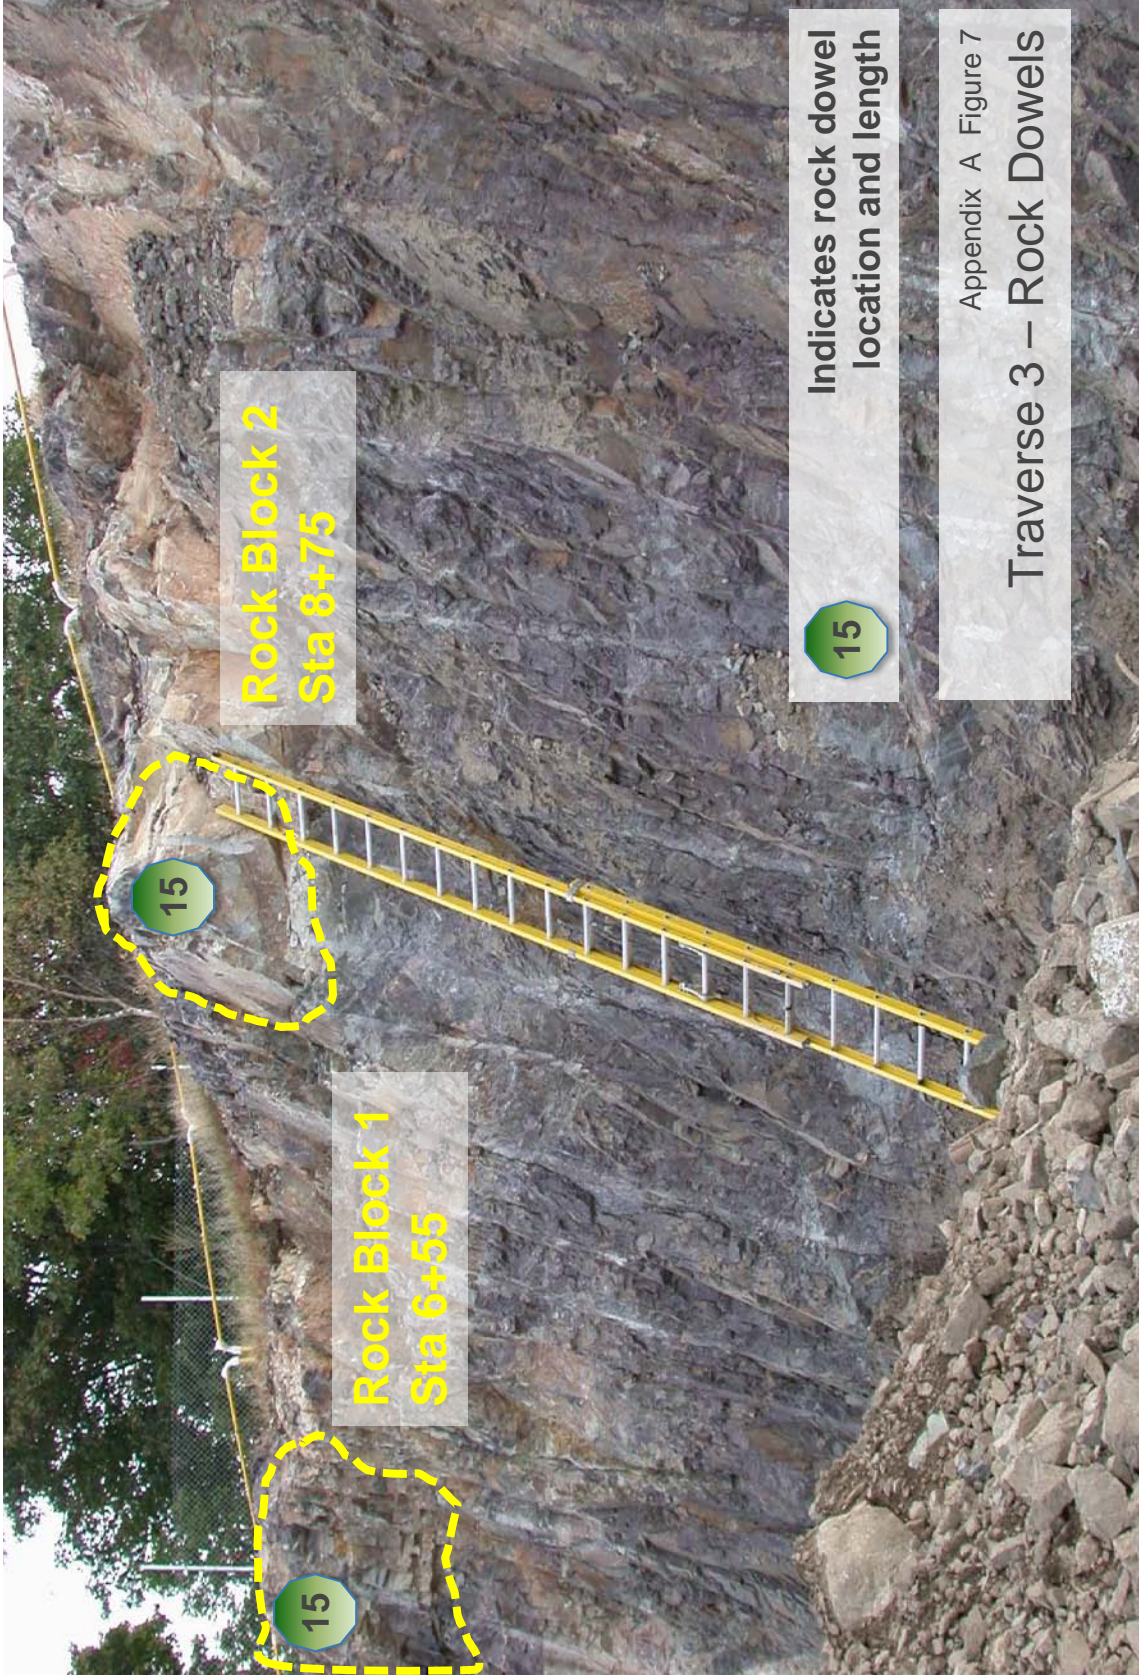
Appendix A Figure 7  
Traverse 3 – Rock Dowels

During the field mapping, we observed a few areas where potential rock wedge failures were considered possible. Also, large rock blocks were present at the top of the rock in two locations.

Rock Block 2  
Sta 8+75

Rock Block 1  
Sta 6+55

- The rock dowels shall consist of #4 (1/2" diameter) galvanized steel, Grade 60 Allthread Rebar manufactured by Williams Form Engineering, part number R50-04, or approved equivalent. Install up to twelve (12) passive rock dowels at general locations indicated in Appendix A.

- Minimum dowel length shall be 15 feet long, installed at 5 degree angle below horizontal in minimum two (2) inch diameter drill holes, and equipped with appropriate centralizers, steel bearing plates, angled or beveled washers, and hexagonal nuts. The use of couplers shall be minimized.

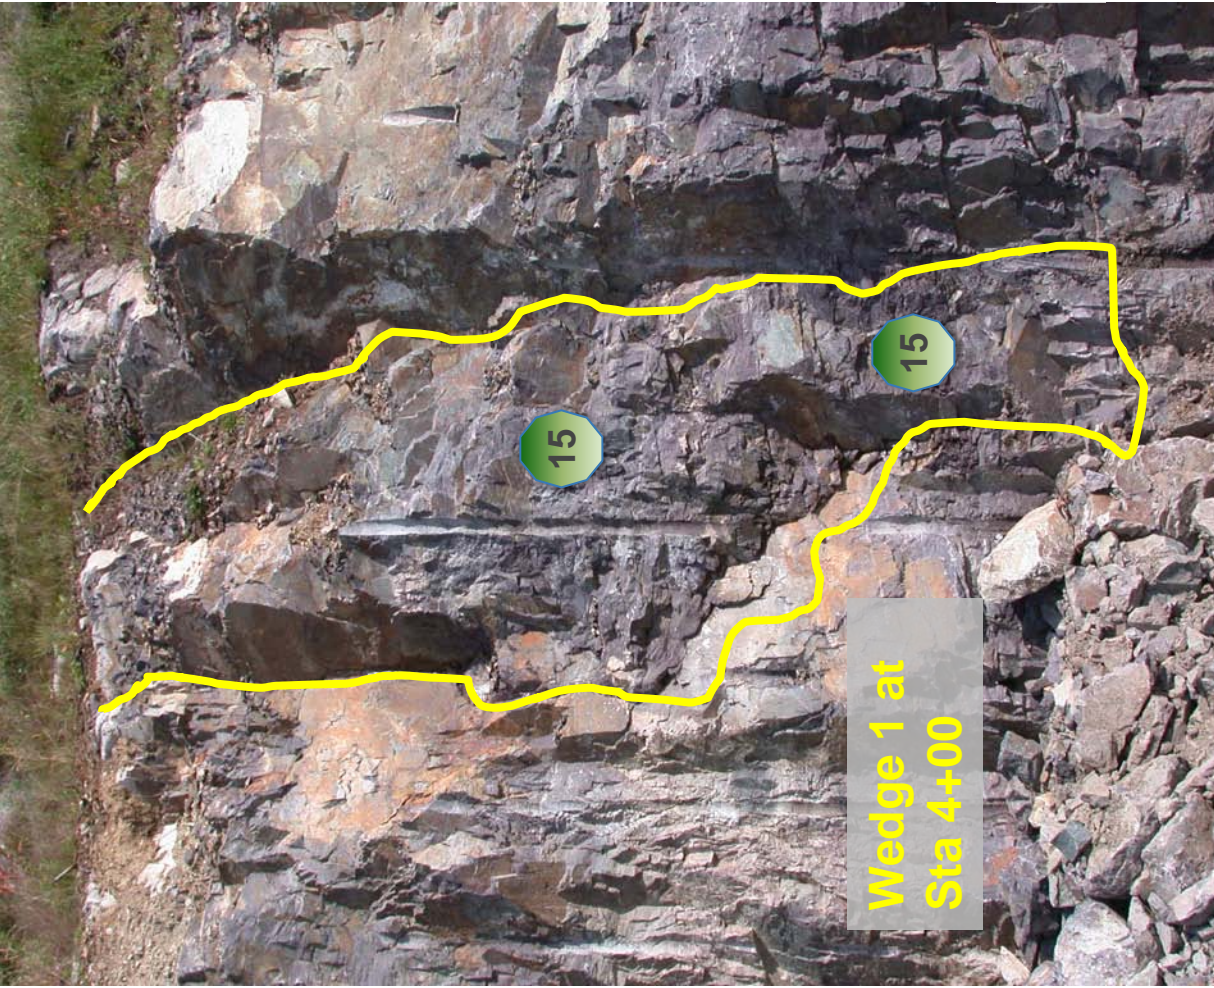
Appendix A Figure 8

The suspect areas were designated “Wedge 1” (located in the vicinity of Sta 4+00) and “Wedge 2” (located near Sta 10+29), and further evaluated using RocScience’s SWEDGE program, a limit-

The results of the wedge stability analysis indicated that although Wedge 1 and Wedge 2 are stable in their current configuration (with a Factor of Safety equal to or greater than 1), they may become potentially unstable over time due to water infiltration, frost action, "relaxation" of the rock mass after blasting and unloading, and loss of buttressing rock block support below the wedges.

Wedge 1 at  
Sta 4+00

## Traverse 3 – Rock Dowel Location

Accordingly, we recommend the installation of passive reinforcement rock dowels in the subject wedges, to prevent or minimize future rock fall from potential wedge failures. By design, passive rock dowels serve to supplement the resistance of the rock wedges from sliding forces, should the rock wedges release and consequently engage the shear capacity and strength of the rock dowels.

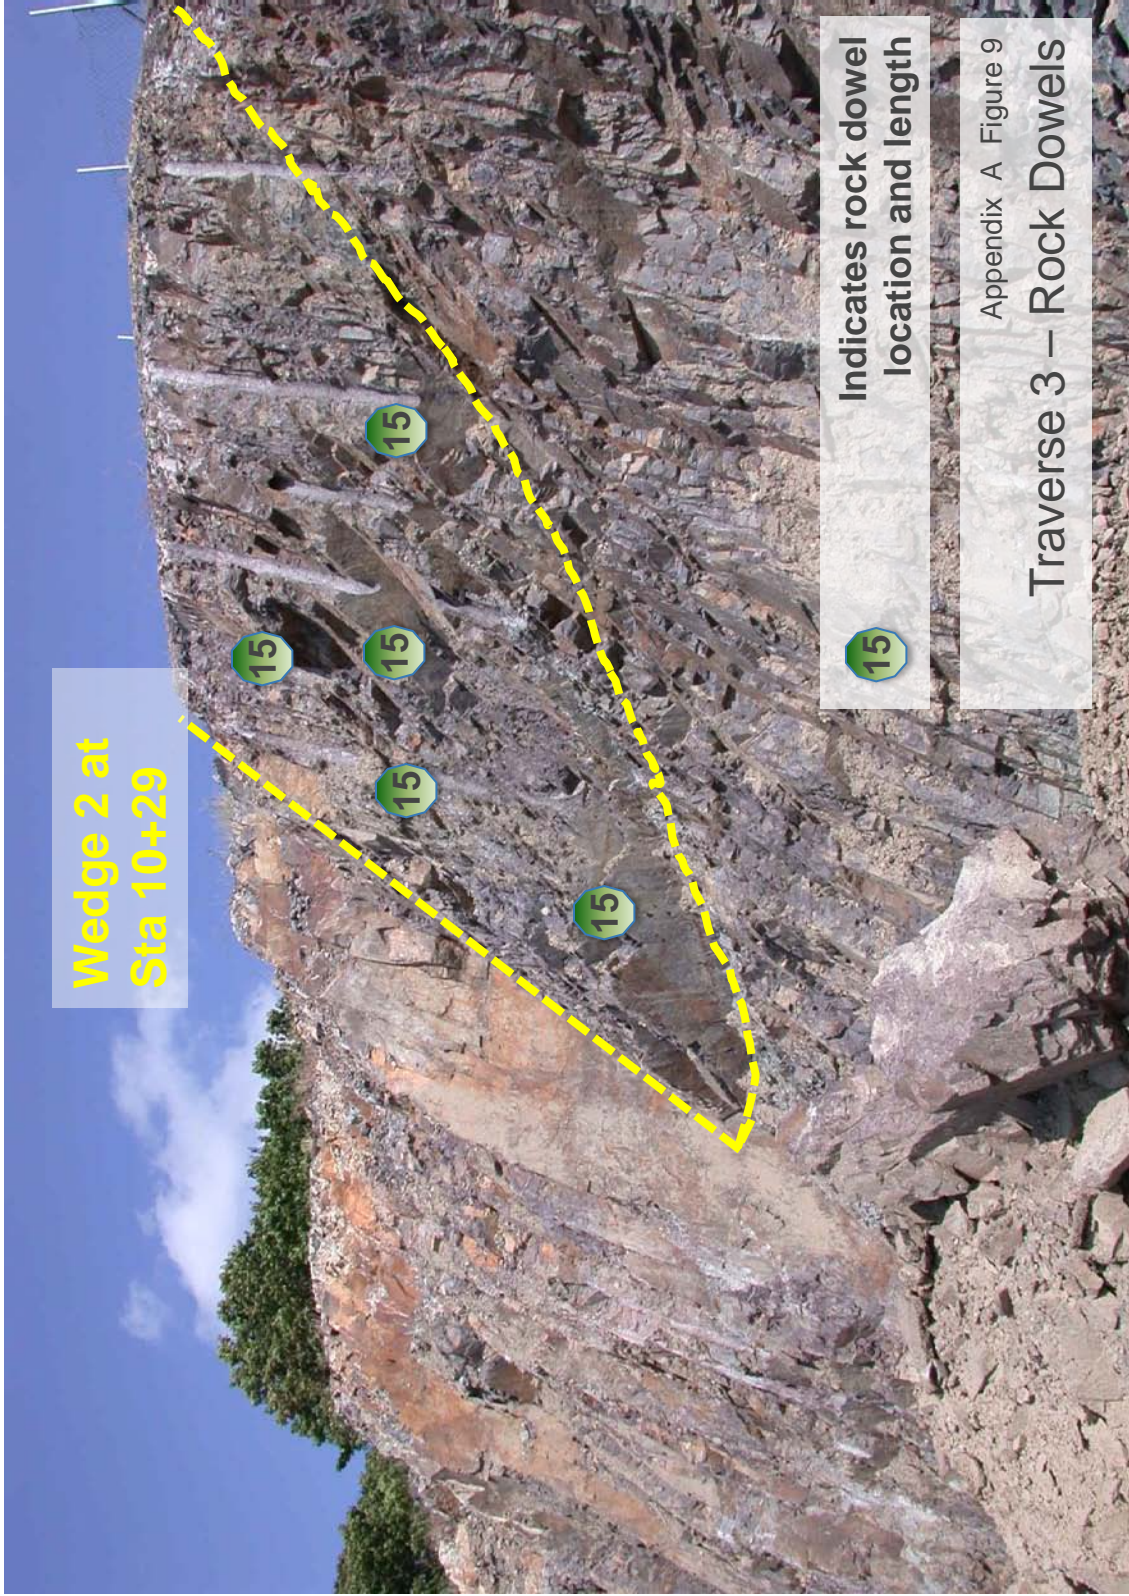
Appendix A Figure 9

Wedge 2 at  
Sta 10+29

Traverse 3 – Rock Dowels
